A2X Firmware 1.5.0 Release Notes

Highlights

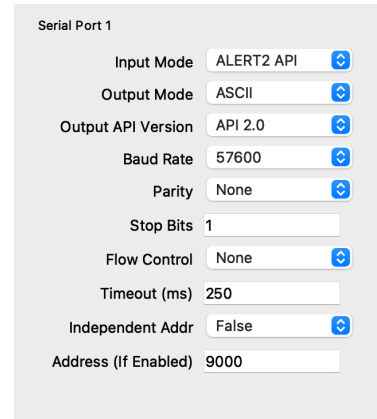
Serial Port 1

Reporting of decoded messages, however, does require explicit selection of an API version. This is done via A2Control, in the serial and network settings sections. There is a new dropdown in the Serial Port interface tab, shown on the right, allowing you to select the Output API Version. In API 2.0, CSV vs binary output is controlled by the Output Mode selector.

- Input Mode: ALERT2 API
- Output Mode: ASCII
- Output API Version: API 2.0
- Baud Rate: 57600
- Parity: None
- Stop Bits: 1
- Flow Control: None
- Timeout (ms): 250
- Independent Addr: False
- Address (If Enabled): 9000

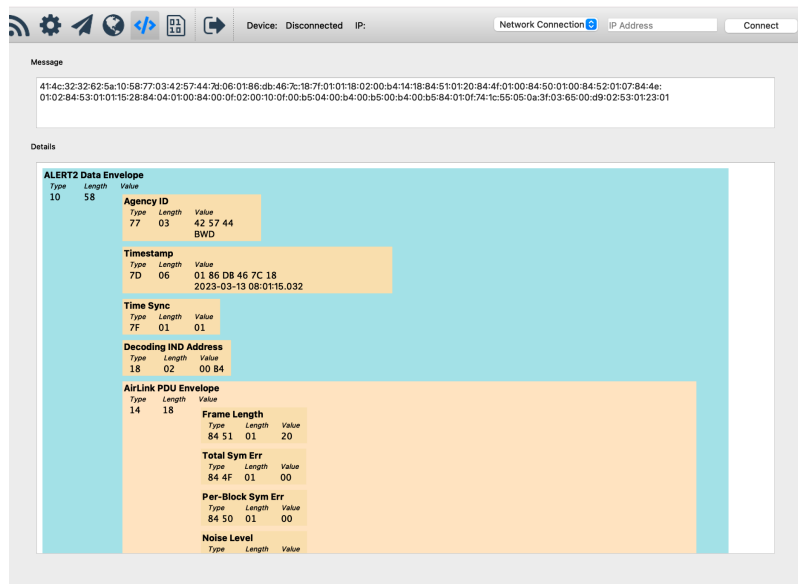
This update includes the addition of a message parser to A2Control. In order to help users visualize and understand binary messages, A2Control now contains a message parser tab. This feature should be a useful tool in understanding the API 2.0 binary message format and developing downstream applications. Additionally, the message parser can process P messages from the API 1.0 format, converting them to an API2.0 format internally and then displaying the results.
